RFQ 25MCO647

RE: Asbestos Inspection - Former Gem Society Structure
801 N. Fort Worth Street
Midland, Texas 79701

ASBESTOS SURVEY COMPLETION REPORT FOR:

Former Gem Society structure
801 N. Fort Worth Street
Midland, Texas 79701

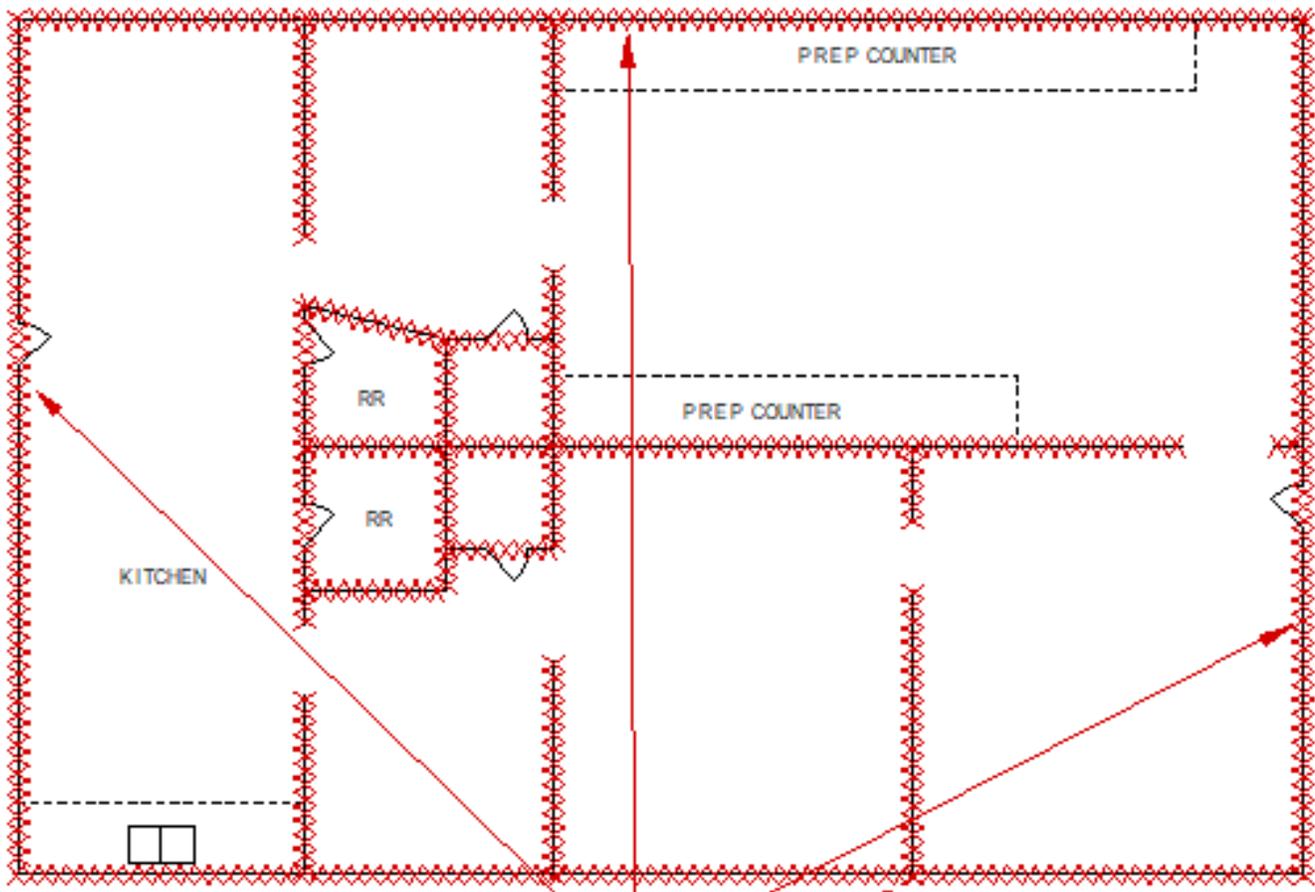
ASBESTOS WALL SURFACING LOCATIONS

Interior & exterior wall surfacing included

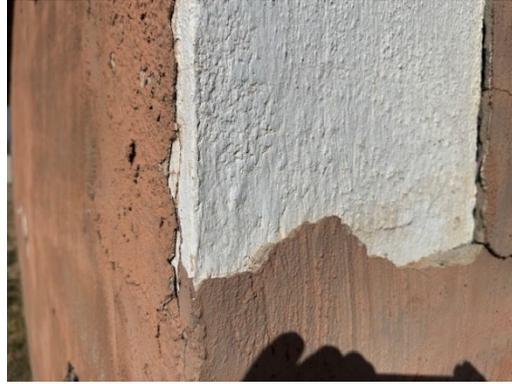
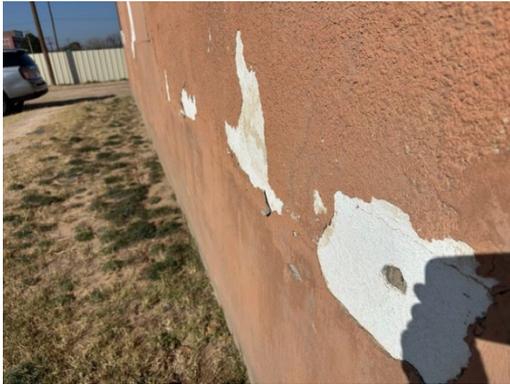
<u>SAMPLE #</u>	<u>AMOUNT</u>	<u>F/NF</u>	<u>CONDITION</u>	<u>TYPE</u>	<u>DESCRIPTION</u>
801FW-01 through 801FW-05	1750 sq ft	Friable	SD	Surfacing	Exterior wall surfacing (multi- layer) on plaster mesh
801FW-09 through 801FW-13	4,200 sq ft	Friable	PD	Surfacing	Wall & ceiling surfacing on sheetrock
801FW-14 through 801FW-16	300 sq ft	Non-friable	PD	Miscellaneous	9" x 9" floor tile with mastic – NE room
801FW-20 through 801FW-22	24 sq ft	Non-friable	PD	Miscellaneous	12" x 12" vinyl square patterned floor square with mastic – restrooms
801FW-23 through 801FW-25	100 sq ft	Non-friable	PD	Miscellaneous	Tan vinyl sheeting – NE room prep tables & kitchen counter

Exterior surfacing on plaster mesh (Samples 1-6)

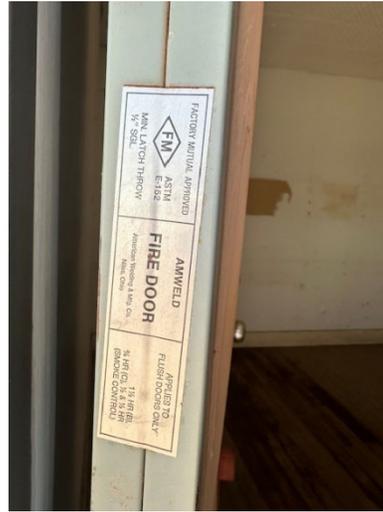
PACM fire door at east entrance of building

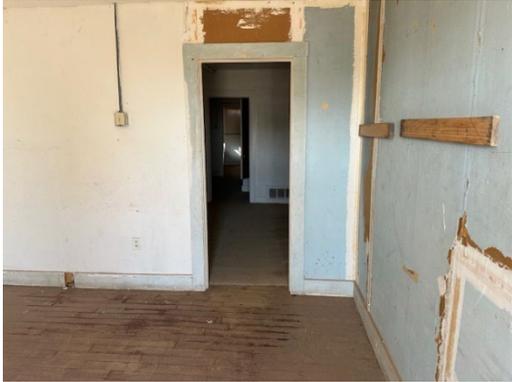
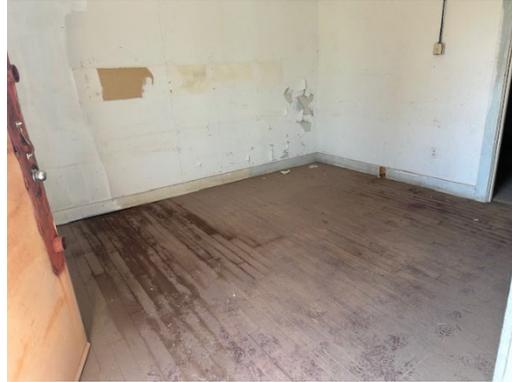
Typical wall surfacing material (Samples 9-13)

Same as previous.

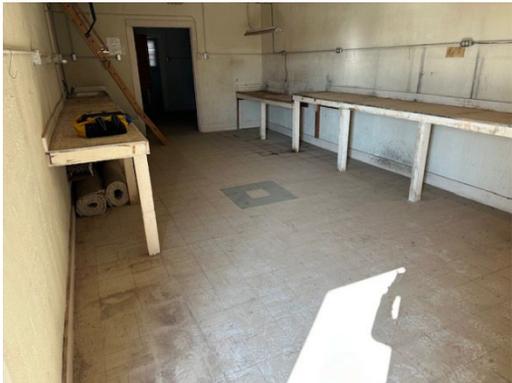
Flooring located in NE room (Samples 14-16)

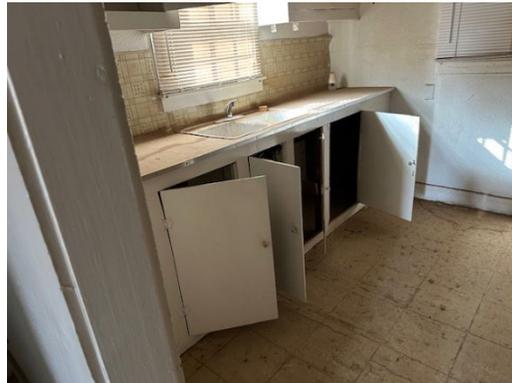
Flooring located in kitchen (Samples 17-19)

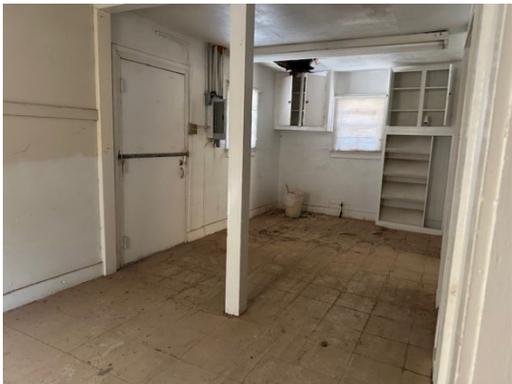
View of north end of kitchen (Samples 17-19, flooring)

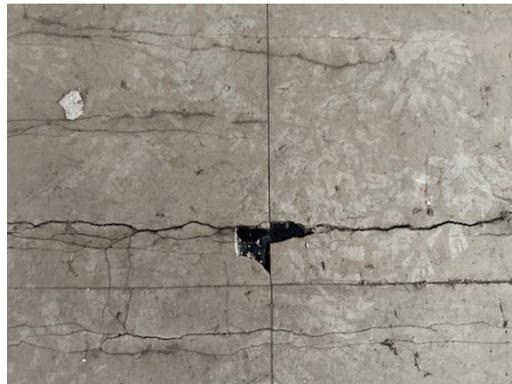
Close up view of kitchen flooring (Samples 17-19)

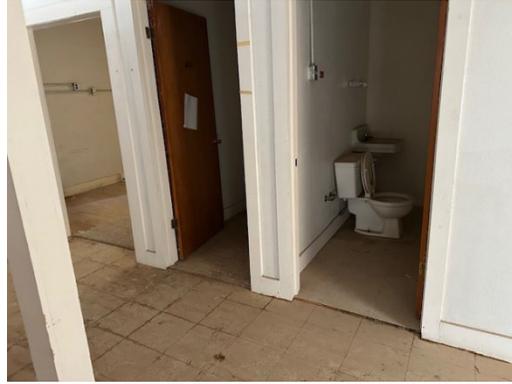
View of restroom flooring (Samples 20-22)

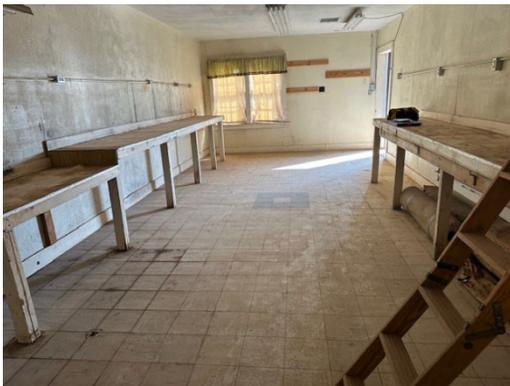
View of vinyl sheeting on counter tops in NE room (Samples 23-25)
