## RFP 23MCO604

### In response refer to RFP NO. 23MCO604 Addendum 2 and Response to Questions March 24, 2023

## Asbestos Survey Report

Project:  
300 S. Baird Street  
Midland, TX

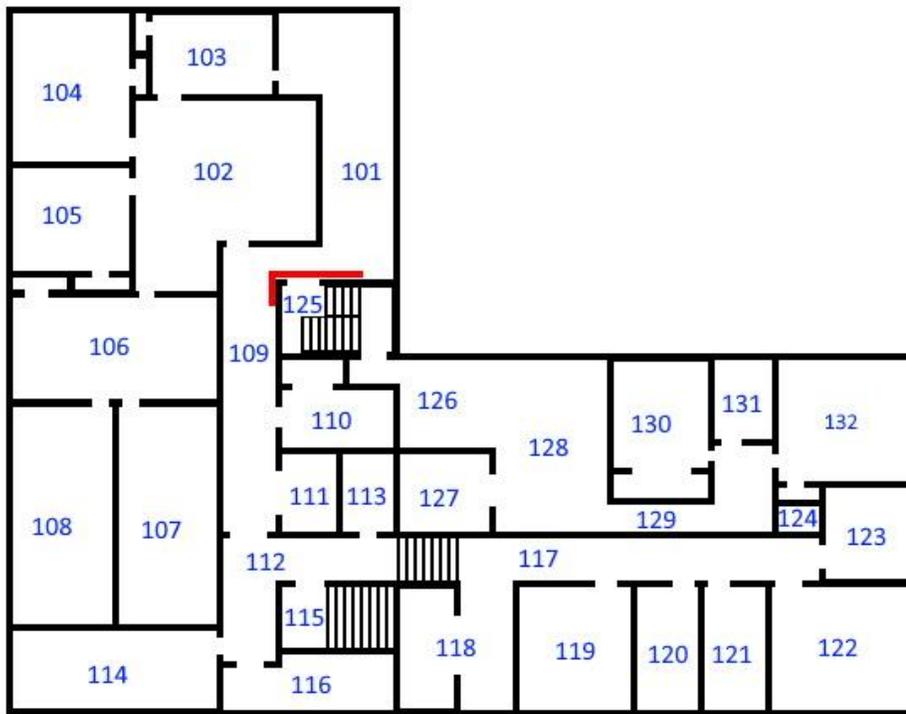
Ground Floor  
ACM Pipe & Fitting Insulation

Pipe insulation (ACM mud/mastic on outer layer in some areas) and Pipe Fitting Insulation. These materials are assumed to exist throughout the building.

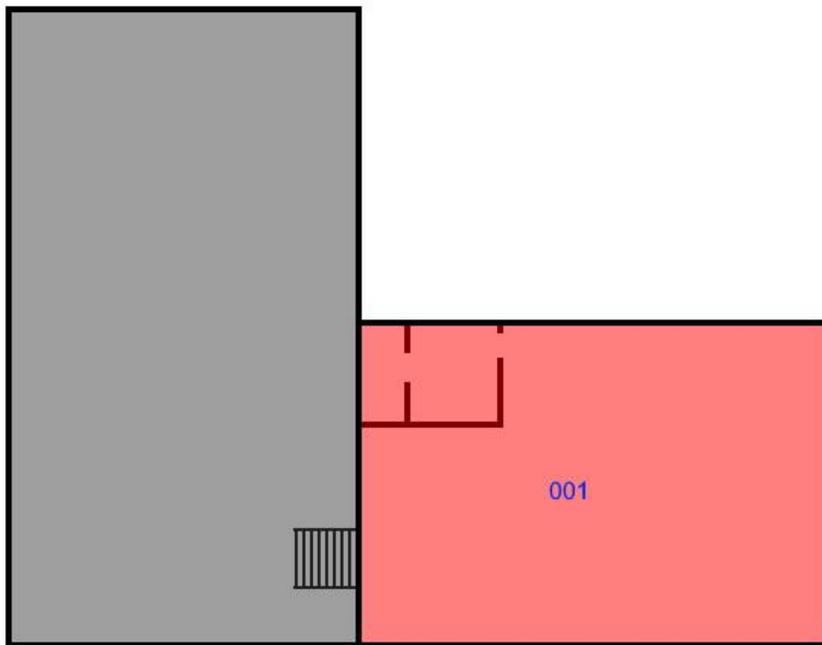
Basement  
ACM Ceilings

C02 - Popcorn Ceiling Texture

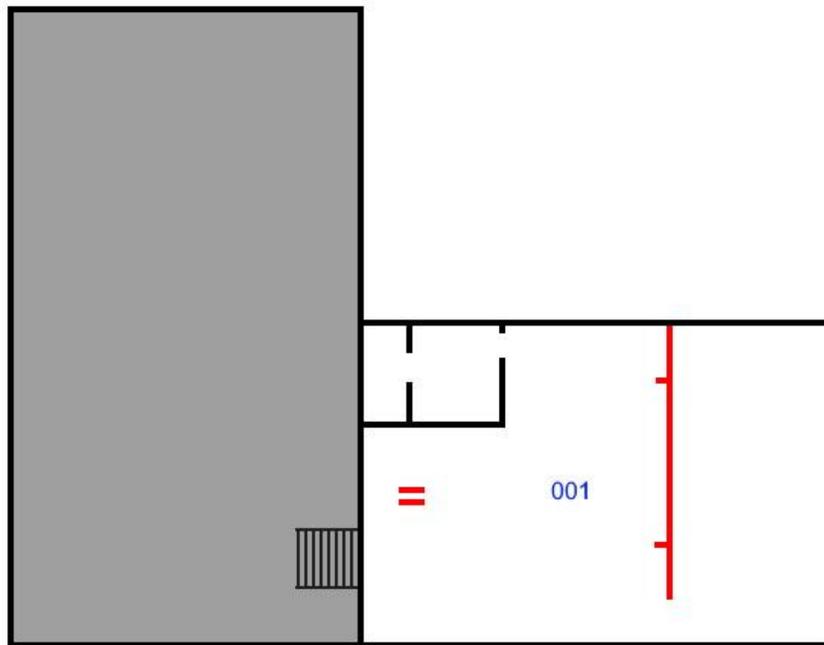
Basement  
ACM Pipe & Fitting Insulation

Pipe insulation (ACM mud/mastic on outer layer in some areas) and Pipe Fitting Insulation. These materials are assumed to exist throughout the building.

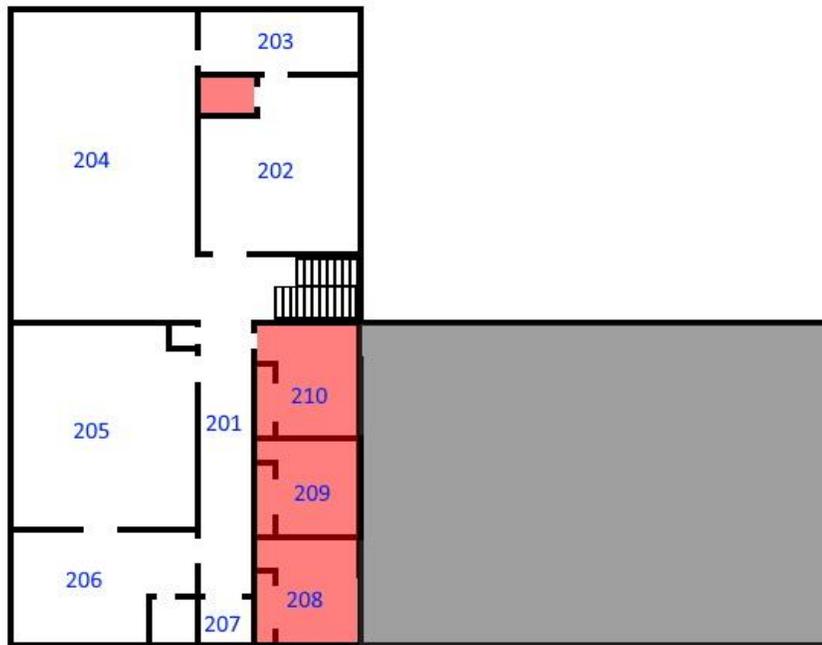
2nd Floor  
ACM Ceilings

C02 - Popcorn Ceiling Texture

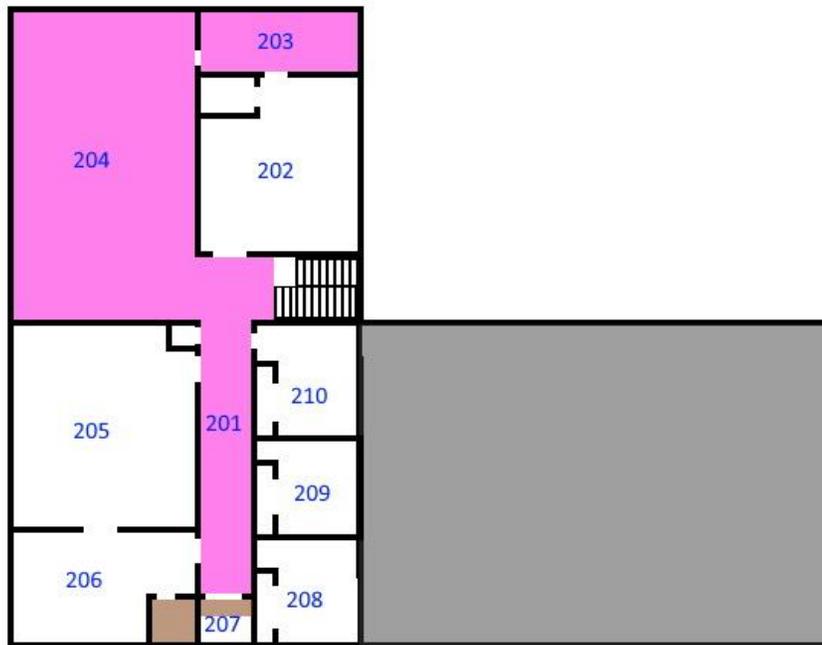
2nd Floor  
ACM Floors

F01 - 12x12 Resilient Floor Tile - White w/ Multi Accents & Black Mastic

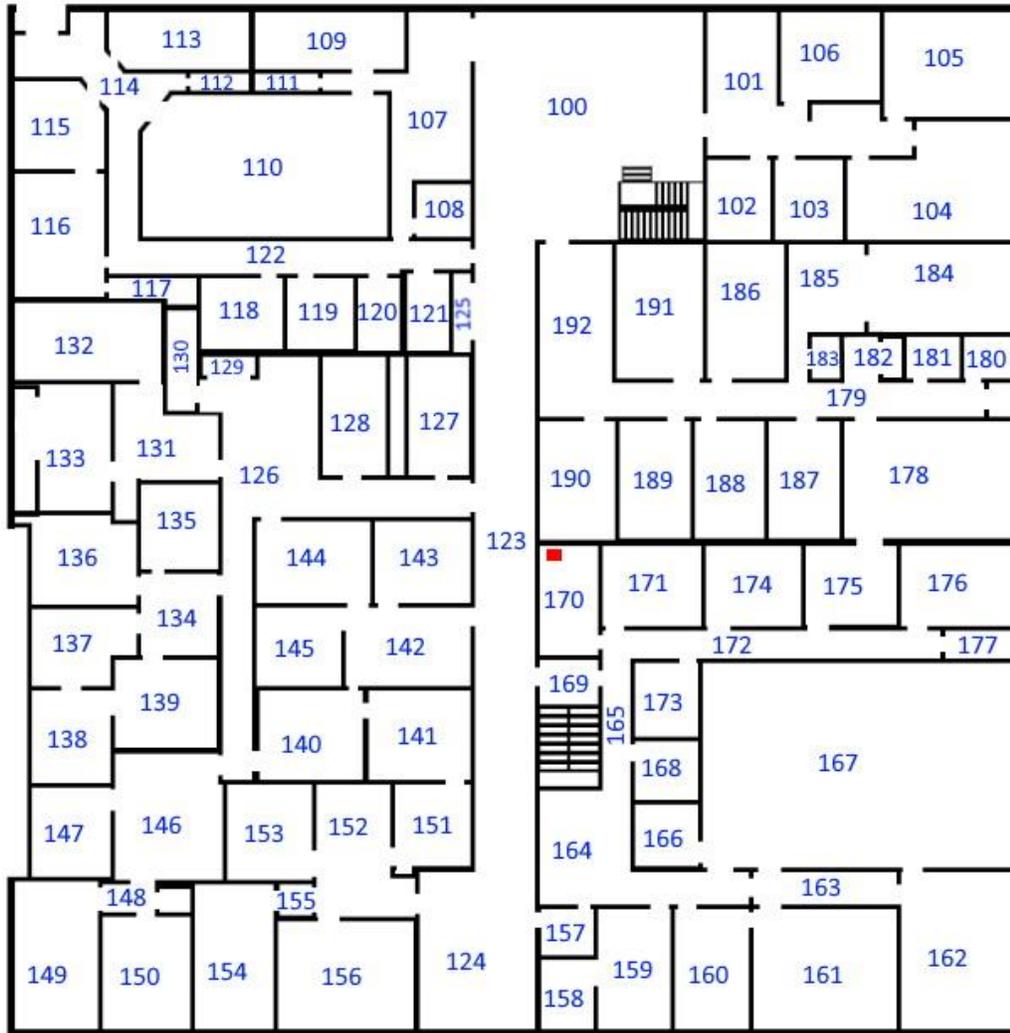
301 S. Main  
Ground Floor  
ACM Sink Undercoating

Homogeneous material M01 – Sink Undercoating - White was assumed to contain asbestos to prevent damage to the sink.

Asbestos-containing materials should be abated prior to demolition or renovation activities which would cause the materials to be disturbed.

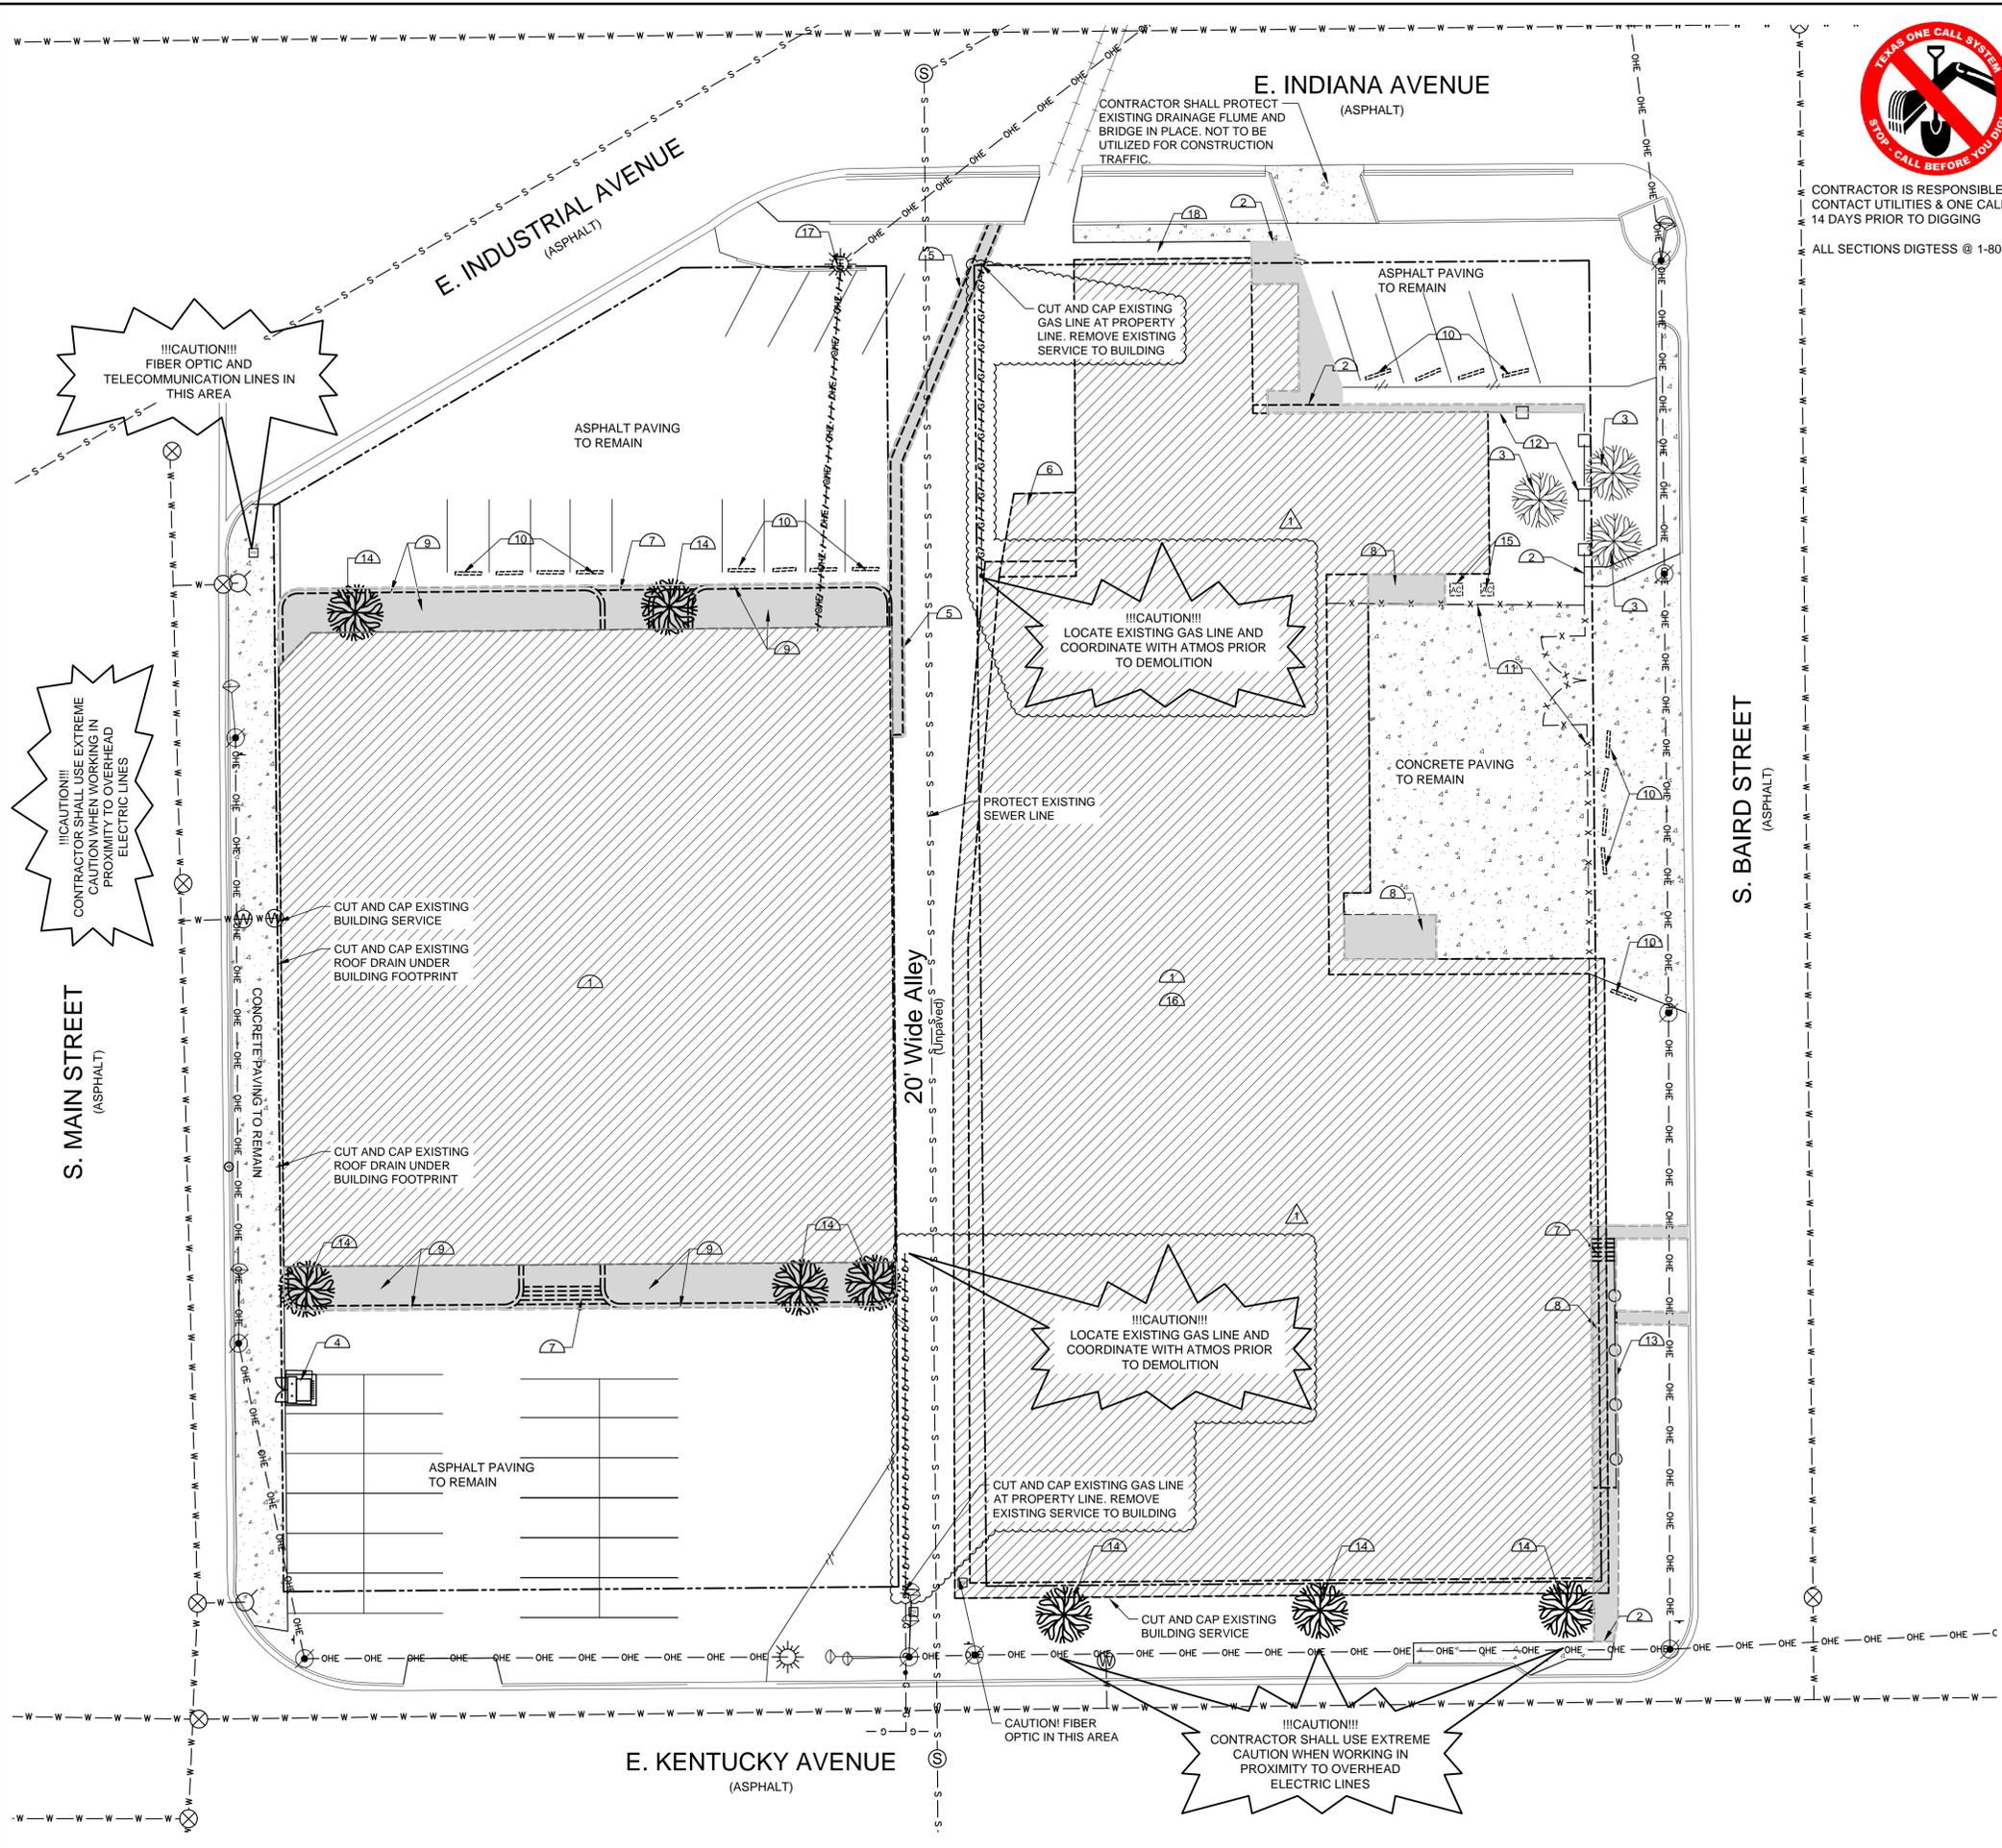
9. Demo note D on CD101 states "contractor is responsible for all miscellaneous repairs due to demolition damage, at own expense". The concrete to remain in close proximity to the building will sustain some damage during the removal of the footings. Will this be considered for repair? Or should we just sawcut the necessary distance back?

Sawcut the necessary distance back to create a clean, straight line.
