# Texas Consulting Services

April 28, 2025

Re: Limited Mold Assessment – Midland County DA Storage – 2200 E. New Jersey

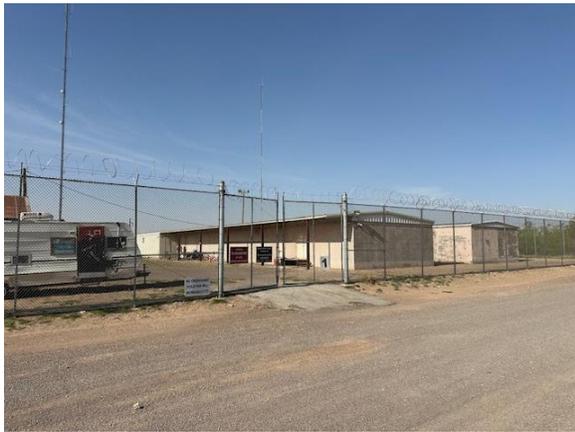
Photo 1: Exterior of Facility Sampled

- The only area of the facility sampled is the northern most 3,200 SF (under roof) portion of the larger 9,400 SF facility. This consultant was not allowed access to the southernmost portion of that facility. The layout of the facility consists of multiple aisles of file storage within the four (4) exterior, CMU perimeter walls. Previous moisture damage has affected the interior side of all exterior walls in the area sampled with evidence of moisture and/or condensation damage on cardboard file storage boxes.

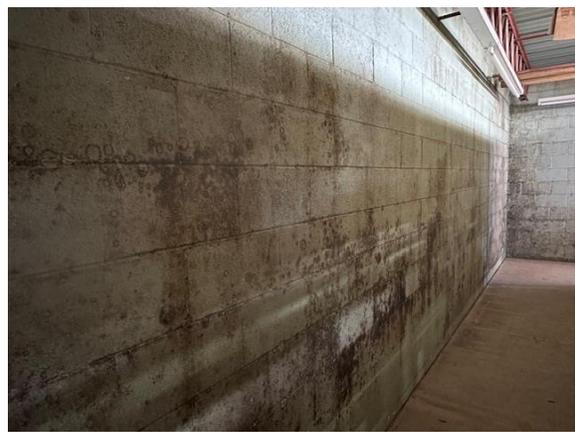
- There is evidence of moisture intrusion from the roof affecting perimeter walls and mold growth prevalent on those perimeter walls. This growth was sampled as part of this assessment. This consultant estimates approximately 2,600 SF of interior walls.

Photo 2: Visible Mold Growth – Int. North Wall

- The visible water damage and fungal growth identified in the facility should undergo remediation according to the Texas Mold Assessment and Remediation Rules (TMARR). This consultant would assemble a remediation protocol that includes removal of the visible mold growth affecting interior walls by the water damage and decontamination of the interior contents.

- This consultant would recommend the cause of the water damage (roof leak) be confirmed prior to pursuing remediation by a Texas licensed mold remediation contractor under supervision by a Texas licensed mold assessment consultant. Please do not consider this assessment report a protocol for remedial action.

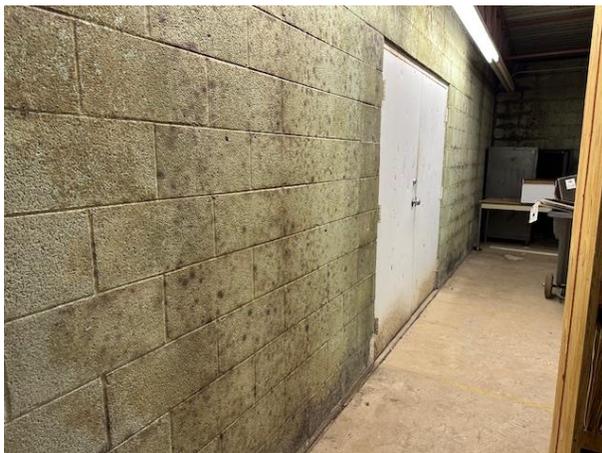
Photo 3: Visible Mold Growth – Int. South Wall

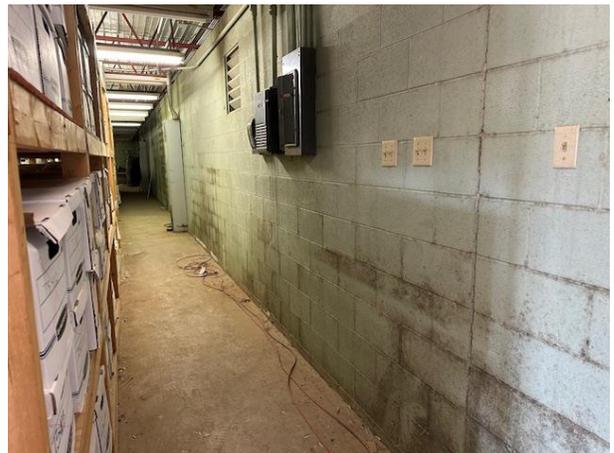
Photo 4: Visible Mold Growth – Int. West Wall

- The composite wall sample discovered “Substantial” mold presence identified as *Cladophialophora*. This growth is likely growing on interior paint and is most certainly present due to moisture intrusion into the facility.

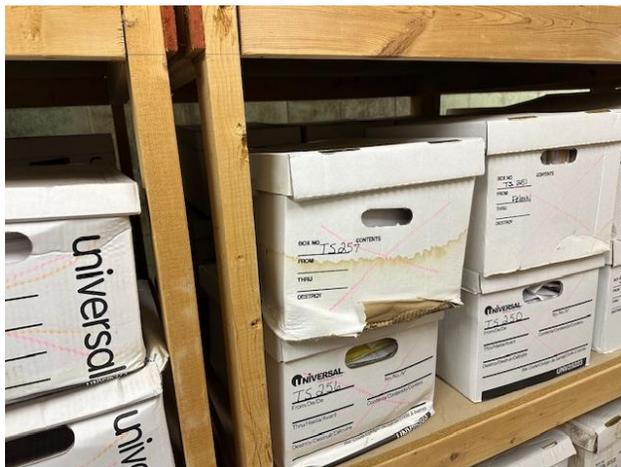
- The intrusion of moisture into the facility and the resultant elevation in humidity due to no HVAC measures in the interior has promoted some moisture damage to cardboard boxes in the file storage aisles.

Photo 5: Moisture Damage Center Aisle Files

- The surface sample taken from the center aisle file boxes identified “Light” mold presence of various mold spores not indistinguishable from other air samples taken in the facility.

- This consultant would further recommend that storage of contents (especially files and porous, cellulose based products) should be in a HVAC controlled environment to reduce interior humidity levels and mitigate mold/bacterial damage.

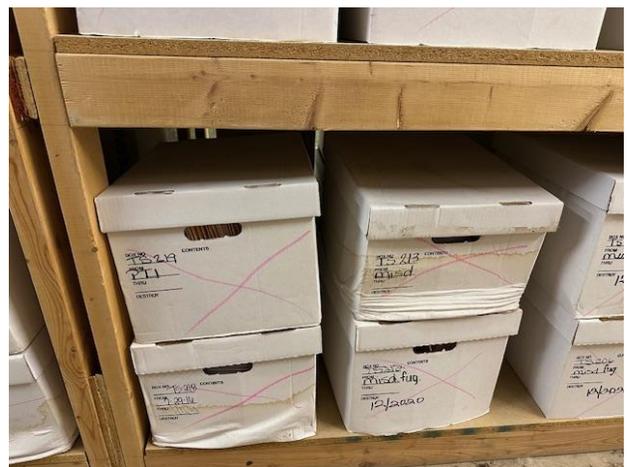
Photo 6: Moisture Damage Center Aisle Files
