Texas Consulting Services

June 18, 2025

Re: Limited Mold Assessment – Midland County JP Storage – 2200 E. New Jersey

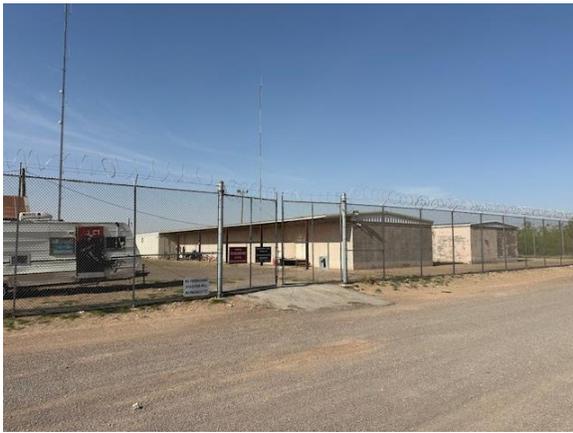
- The area of the facility sampled is the southernmost 6,200 SF (under roof) JP storage portion of the larger 9,400 SF facility. The layout of the facility consists of multiple aisles of file storage within the four (4) exterior, CMU perimeter walls. Previous moisture damage has affected the interior side of the north, interior wall in the area sampled with evidence of heavy particulate and debris collection on the files/contents stored in the area.
- This facility is not occupied under normal circumstances and is only utilized for material storage.
- The southern portion of this area has suffered settling damage to the CMU walls with cracks allowing visible sunlight into the interior.

Photo 1: Exterior of Facility Sampled

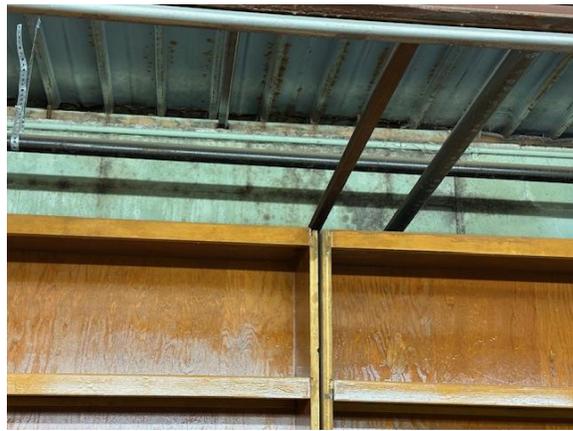
- No air conditioning or HVAC control was observed or evident at the time of this assessment. This consultant has been informed that roof repairs have been carried out. Water damage to the interior side of the roof is visible near the northern interior wall of this area.

- There is evidence of moisture intrusion from the roof affecting the north, interior wall with mold growth prevalent on that wall. This growth was sampled as part of this assessment. This consultant estimates approximately 400 SF of interior wall damage due to mold/water damage.

Photo 2: Visible Mold Growth and Water Damage to Roof – Int. North Wall

- The visible water damage and fungal growth identified in the facility should undergo remediation according to the Texas Mold Assessment and Remediation Rules (TMARR). This consultant is assembling a remediation protocol that includes removal of the visible mold growth affecting interior walls by the water damage and decontamination of the interior contents.
- This consultant would further recommend that future storage of contents (especially files and porous, cellulose based products) should be in a HVAC controlled environment to reduce interior humidity levels and mitigate mold/bacterial damage.
- This consultant would recommend personnel avoid the interior environment of this facility due to the elevated amount of mold growth and contaminated elements within. Remediation should be pursued on an ASAP basis.

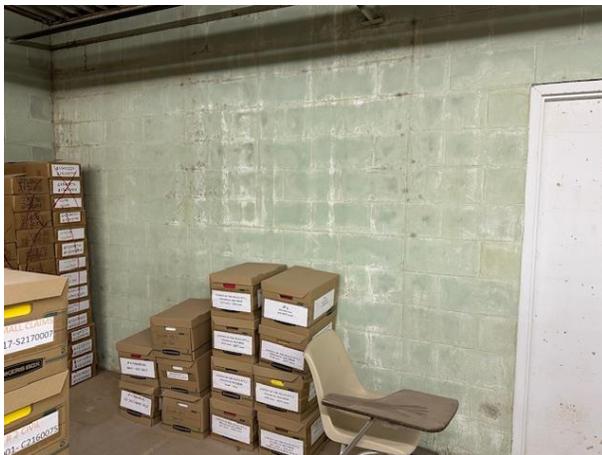
Photo 3: Visible Mold Growth and Water Damage Int. North Wall

- The north wall sample identified visible mold growth as *Alternaria*, *Bipolaris* and *Stachybotrys*. This growth appears to be isolated to the north side of the common wall between JP and DA storage. This is consistent with the damage discovered along all perimeter walls of the DA storage area.

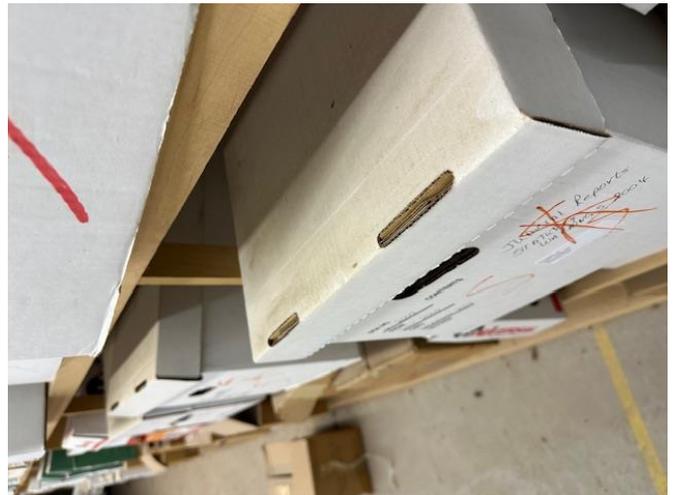
Photo 4: Particulate and Debris on Files

- The surface samples taken from the file boxes identified “Light” mold presence of various mold spores not indistinguishable from other air samples taken in the facility.

- **Debris:** The lab analysis includes a rating and basic breakdown of “Debris” for each sample collected. Debris is scaled from a “1/5” (least/trace) to a “5/5” (Extensive). With these ratings denoted by the lab analyst, this consultant uses that determination to aid in protocols for remediation as well as determining other particulates that may be concerning to occupants or workers in the environment. This sampling event discovered consistent debris ratings above that discovered in the exterior (prevalently 5/5) in both interior air and surface samples. This debris can be made up of dirt, dust, silica, inspect parts and other non-descript material that can act as irritants and/or allergens to occupants and workers.
