## RFP 23MCO604

### In response refer to RFP NO. 23MCO604 Addendum 2 and Response to Questions March 24, 2023

## Asbestos Survey Report

Project:  
300 S. Baird Street  
Midland, TX

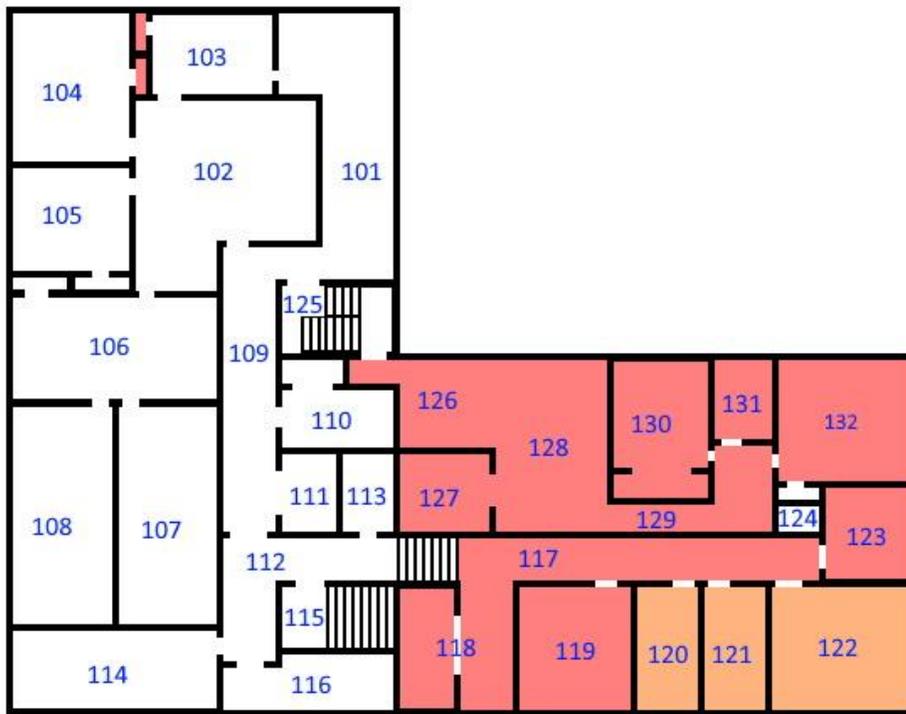
Ground Floor  
ACM Ceilings

HA	ACM	Description	Est. SF
C01		24x24 Suspended Acoustical Tile - Fissured & Perforated	3145
C02	*	Popcorn Texture	2248
C03		Vinyl-Covered Gypsum board	1263
C04	**	Drywall w/ Tape, Bed, & Drag Texture	297
C05		24x48 Suspended Acoustical Tile - Fissured & Perforated	10935
F01	*	12x12 Resilient Floor Tile - White w/ Multi Accents & Black Mastic	1633
F02	*	12x12 Resilient Floor Tile - Brown w/ Multi Accents & Black Mastic	144
F03		Linoleum - White w/ Multi Accents	846
F04		Linoleum - Gray Slate Pattern	184
M01		Stair Tread Glue - Gold (Under Black Rubber)	105
M02		Window Glaze	100
P01	*	Pipe Insulation	Throughout
P02	*	Pipe Fitting Insulation	Throughout
R01		Rolled Roofing	34160
R02		Roof Flashing	1500
W01		Vinyl-covered Gypsum Panels	15108
W02		Vinyl Cove Base - 6" Brown	177
W03		Vinyl Cove Base - 6" Green	182
W04		Vinyl Cove Base - 4" Brown	223
W05		Drywall w/ Tape, Bed, & Modern Drag Texture	160
W06		Drywall w/ Tape, Bed, & Smooth Texture	2650

Materials containing 1% or greater asbestos should be abated prior to demolition or renovation activities which would cause the materials to be disturbed.

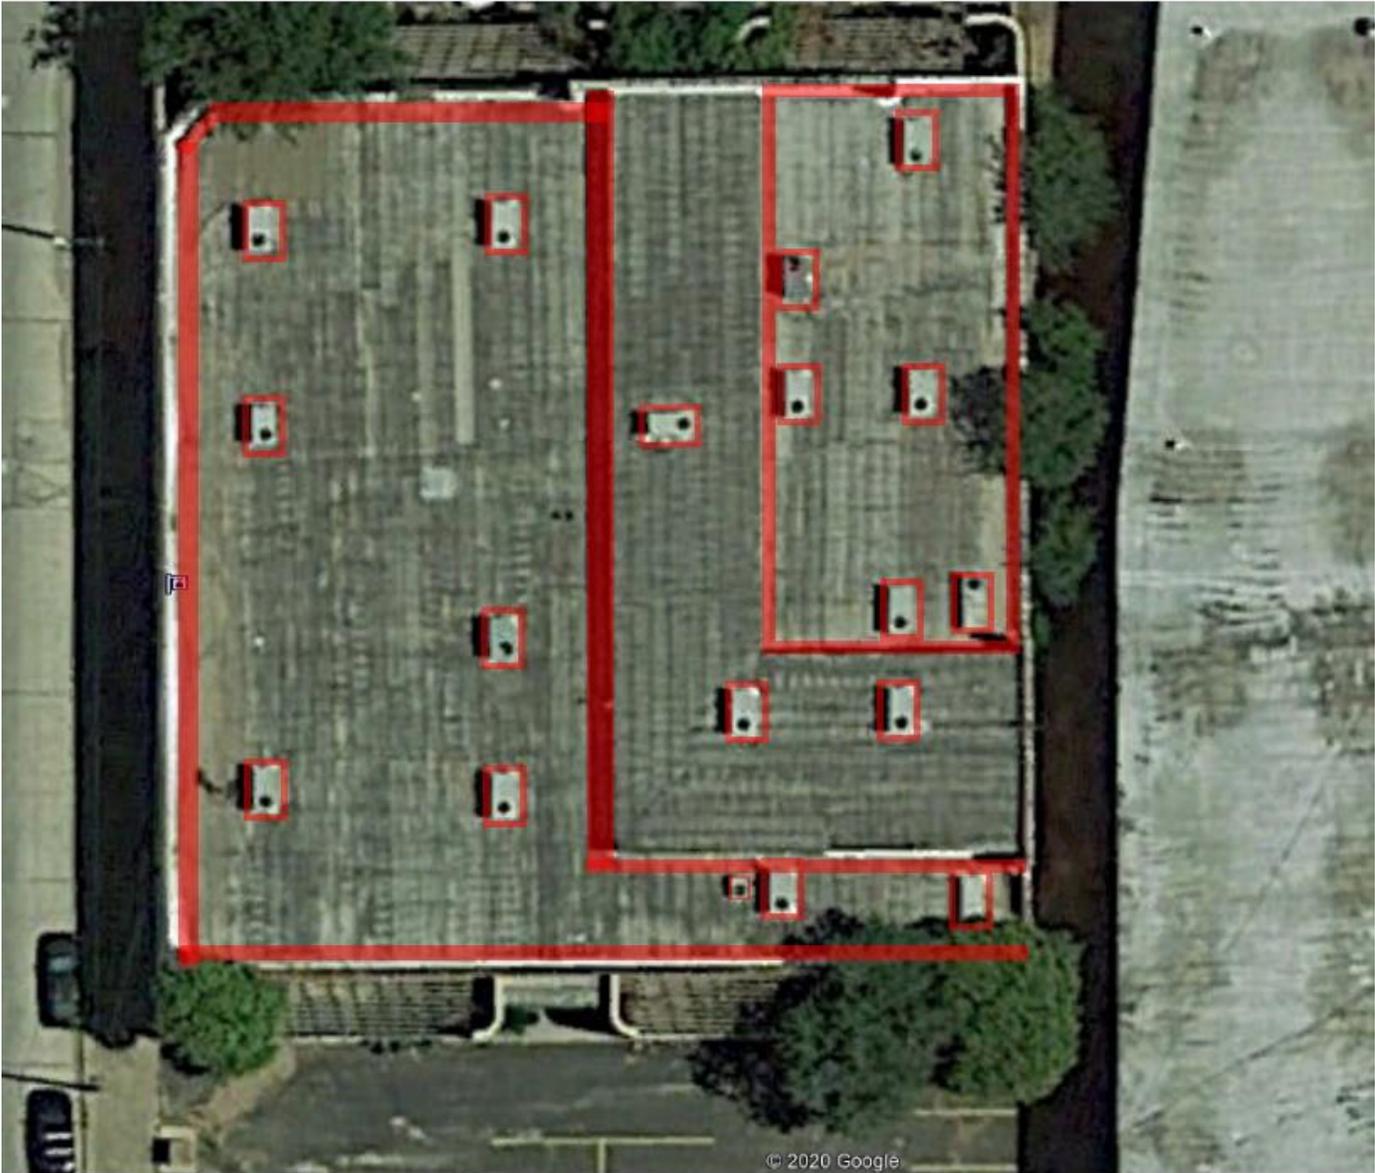
301 S. Main  
Exterior  
ACM Roof Flashing

HA	ACM	Description	Est. SF
C01		24x48 Suspended Acoustical Tile - Fissured & Perforated	19954
C02		Heavy Popcorn Texture	916
C03		24x24 Suspended Acoustical Tile - Fissured & Perforated	292
E01		Stucco	8150
F01		Linoleum - Wood Square Pattern	48
I01		Paper-backed Fiberglass Batt Insulation	21162
M01	***	White Sink undercoating	6
R01		Rolled Roofing	20000
R02	*	Roof Flashing	2836
W01		Paneling Glue - Beige	200
W02		Drywall w/ tape, bed, & light orange peel texture	28359
W03		Vinyl Cove Base - 4" Gray/Brown	2401
W04		Drywall w/ tape, bed, & light drag texture	1372
W05		Drywall w/ tape, bed, & very light spray texture	624
W06		Vinyl Cove Base - 4" Blue	157
W07		Vinyl Cove Base - 6" Brown	126
W08		Wallpaper on Drywall	14874
W09		Drywall w/ tape, bed, & medium drag texture	144
W10		Drywall w/ tape, bed, & heavy drag texture	320

Asbestos-containing materials should be abated prior to demolition or renovation activities which would cause the materials to be disturbed.
