## SPECIFICATIONS AND BID ITEMS

WCR130 EXTENSION FROM  
SCR1232 TO SCR1210  
MIDLAND COUNTY, TEXAS

**CLIENT:**  
Midland County

## GEOTECH REPORT

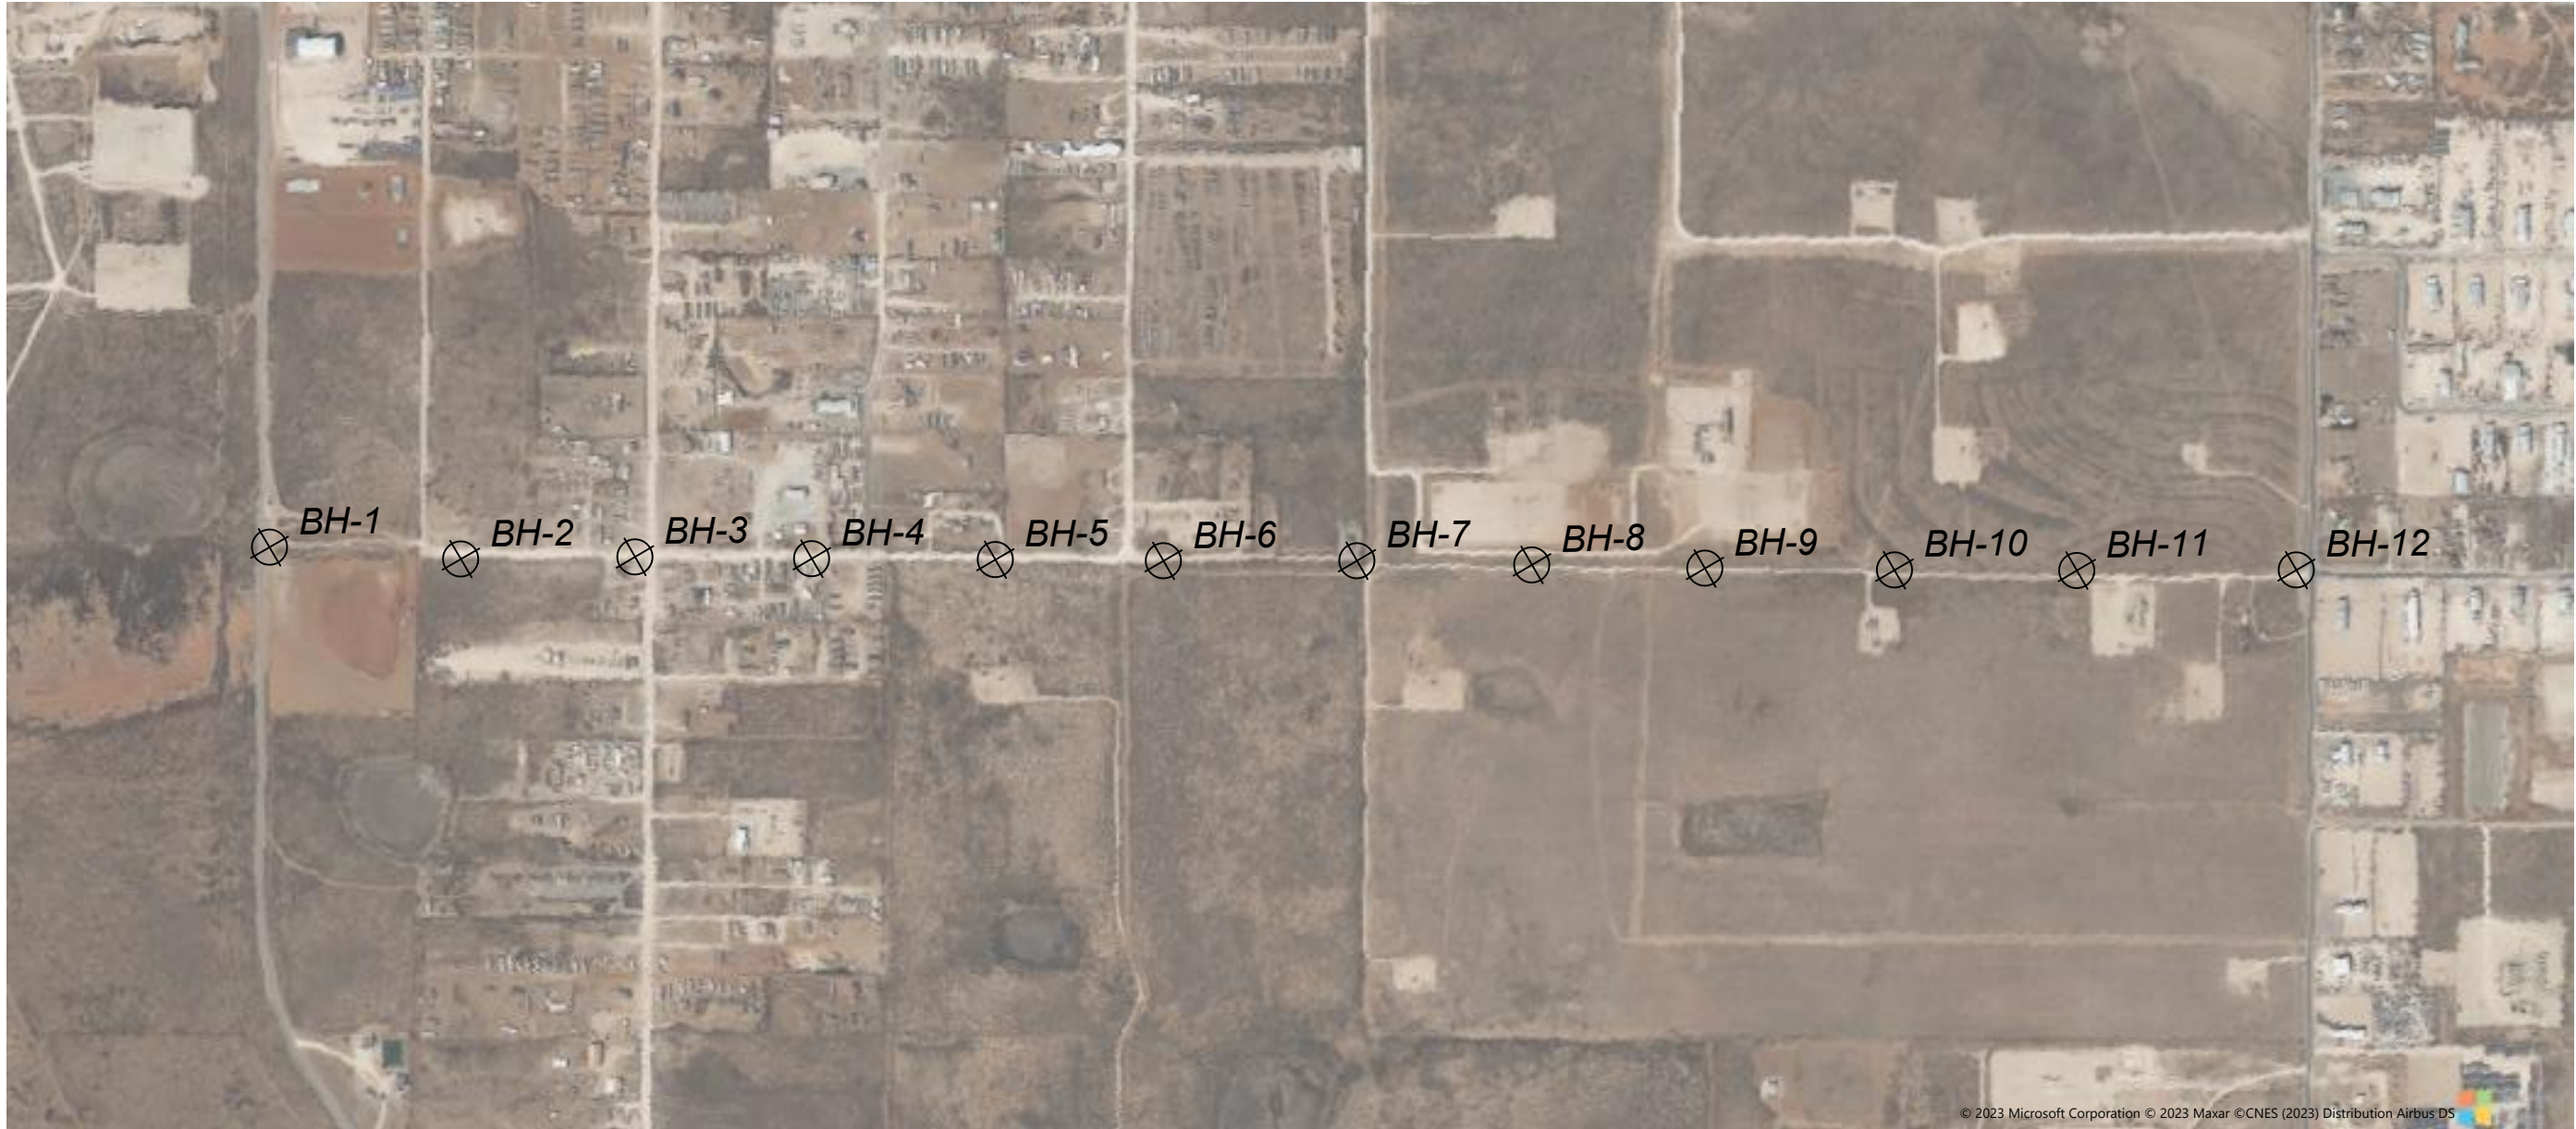
## APPENDIX A: BOREHOLE MAP

On April 11, 2023, twelve exploratory borings were advanced between 4.5 and 5.5 feet below ground surface utilizing a track-mounted Geoprobe drill rig equipped with a 140-lb. automatic hammer. As outlined in ASTM D 1586: Standard Test Method for Standard Penetration Test (SPT) and Split-Barrel Sampling of Soils, disturbed samples were obtained by driving a split spoon 18 inches with a free-falling hammer that was dropped 30 inches. Soil samples were obtained at the intervals shown on the Boring Logs (Appendix B). Each sample was carefully sealed in plastic containers, labeled and secured for delivery to the laboratory. A field log was prepared for each boring. Each log depicts the visual classification of materials encountered during drilling. Boreholes were backfilled after the completion of drilling and sample collection. These borehole locations are shown on the Borehole Map (Appendix A) and summarized in Table 1.
